TECHNICAL REPORT REMR-CS-30

IN SITU REPAIR OF DETERIORATED CONCRETE
IN HYDRAULIC STRUCTURES: EPOXY INJECTION
REPAIR OF A BRIDGE PIER

R. P. Webster, L. E. Kukacka, D. Elling

Final Report

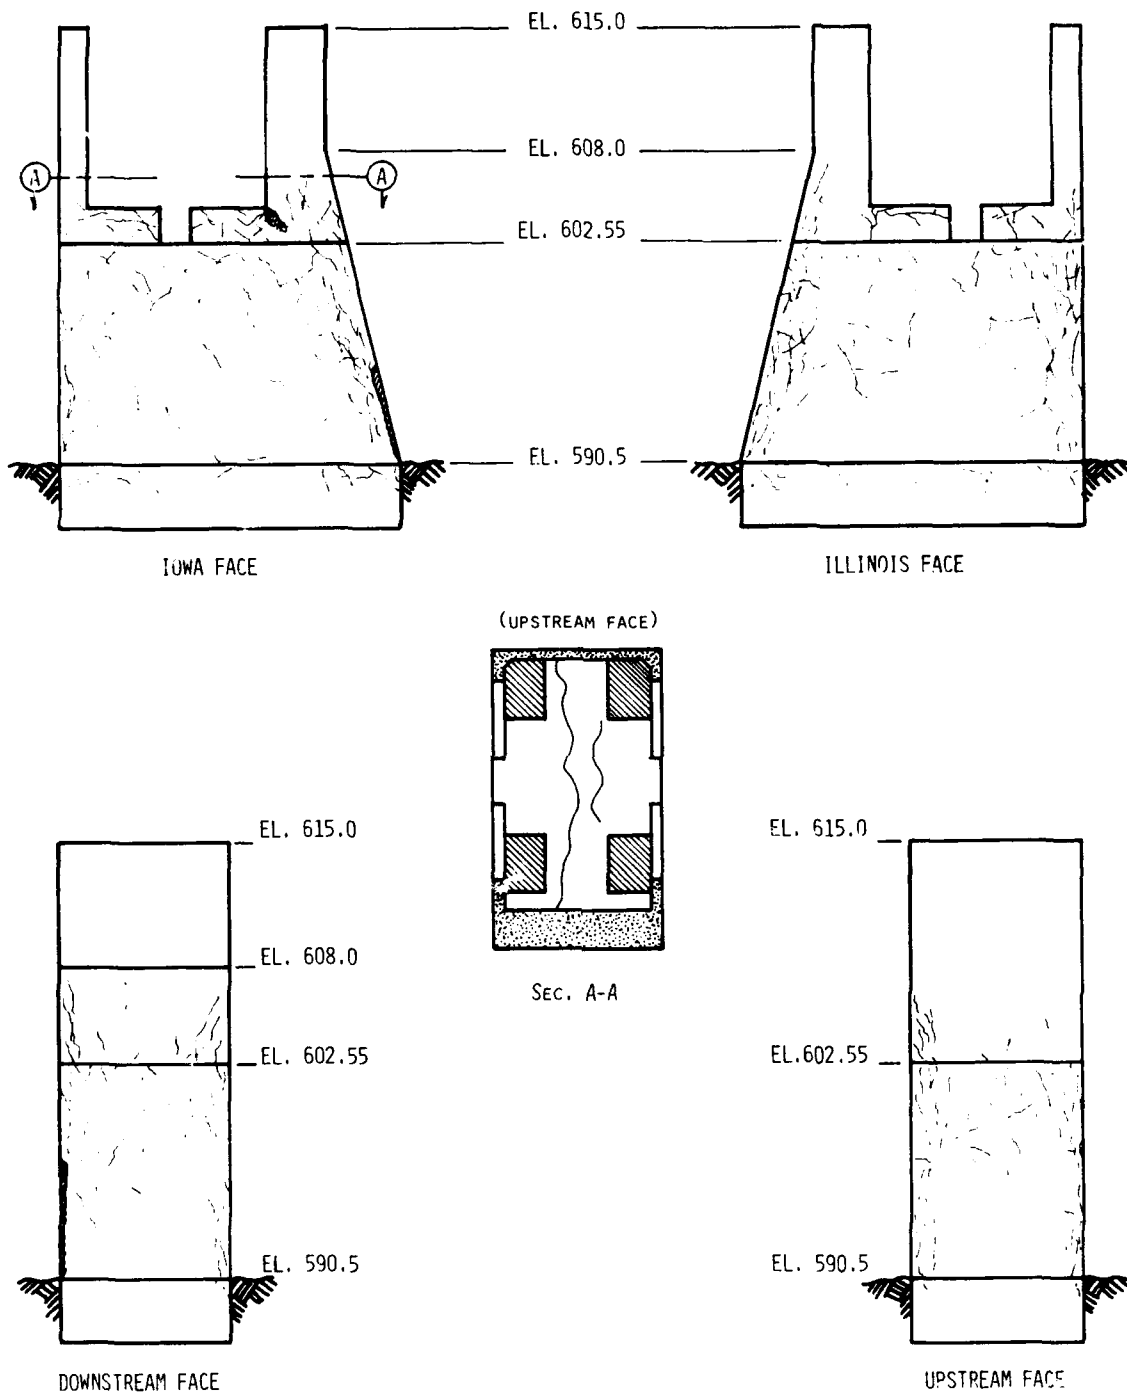
- e. Iowa face - the face was highly cracked around its perimeter, below the level of the construction joint. The interior portion of the face did not appear to be highly cracked; however, it sounded very delaminated. The corner shared with the downstream face, as previously noted, was partially broken away as a result of the cracking and delaminations. The upstream portion of the bearing seat curtain wall was cracked but relatively sound. The downstream half, however, was badly deteriorated and needed to be patched before the cracks could be repaired.

Figure 13. Drawing showing crack patterns

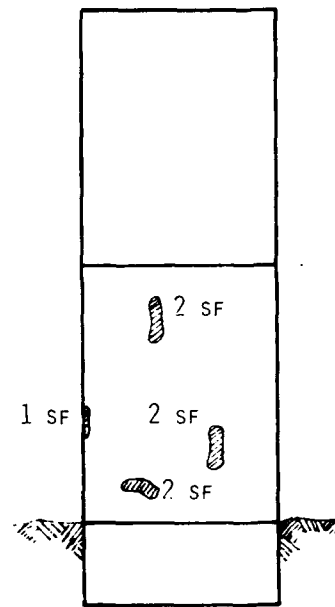
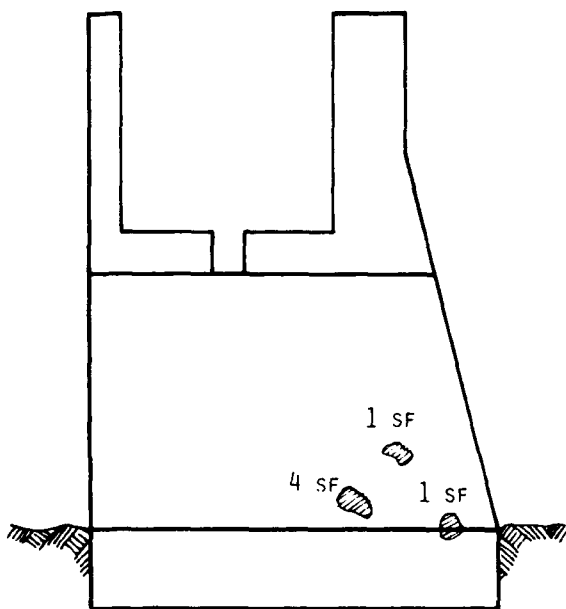
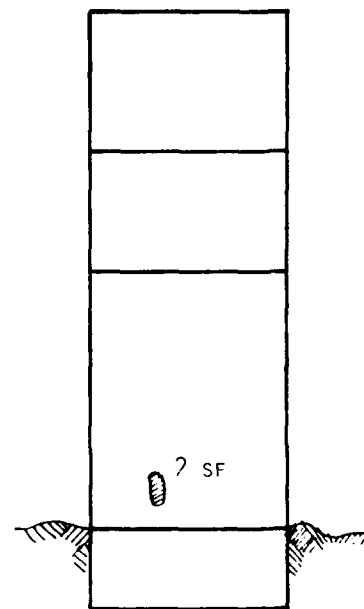
Figure 28. Void areas marked for reinjection
